# **Air-to-Air collisions: Quadcopter Drones VS. Part 25 Category Aircraft**

**Dr. Azzedine Dadouche**

*International Virtual Conference on  
Air Mobility with Unmanned Systems and Engineering (AMUSE)  
16-17 March, 2021*

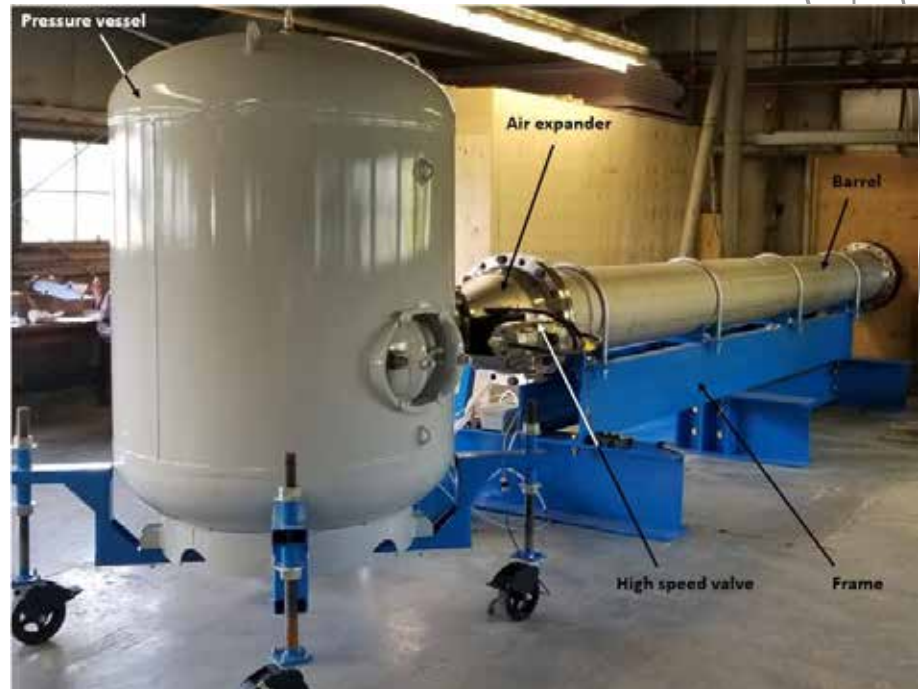
# Drone Cannon

- Called the “Super Cannon”
- Developed at NRC in close collaboration and partnership with TC & DRDC.
- Pilot testing has been conducted on flat plates and selected aircraft segments (Part 23 and Part 25).

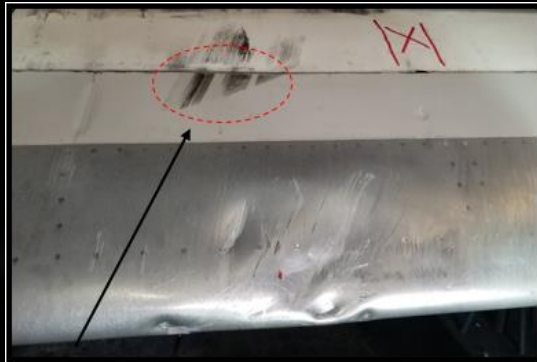
# Drone/slat impact at **140 knots** (Test#2, deployed slat, charged battery)

Ink transfer from sabot

Motor #3

Motor #2

Camera mount

Camera

| Test #,<br>speed (kn) | Severity | Description | Damage picture |
|---|---|---|---|
| 2, 140 | Level 2 | Extensive plastic deformation<br>on external skin.<br>Distortion of secondary parts<br>No failure of skin | |

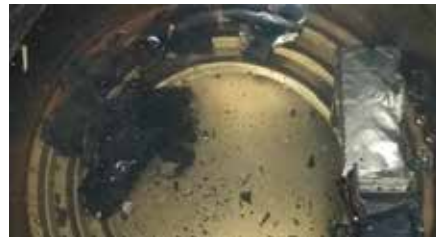
# Drone/slat impact at **250 knots** (Test#6, Retracted slat, charged battery)

| Test #,<br>speed (kn) | Severity | Description | Damage picture |
|---|---|---|---|
| 6, 250 | Level 3 | Extensive failure of the skin<br>Penetration of drone debris<br>inside the fractured area<br>Secondary damage (tracks)<br>Slat jammed in place | |

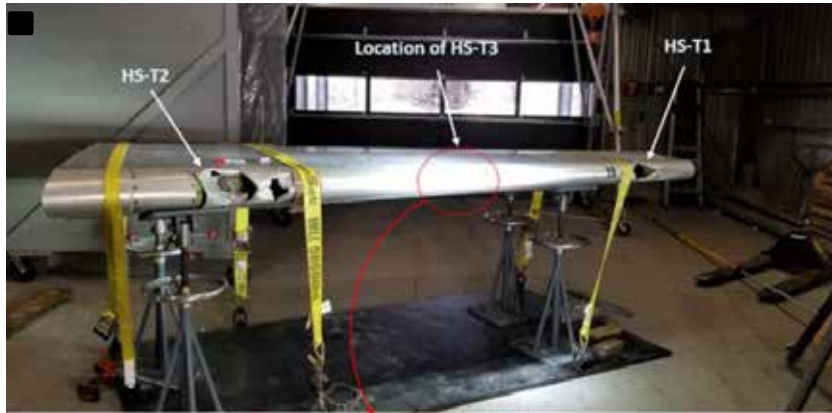
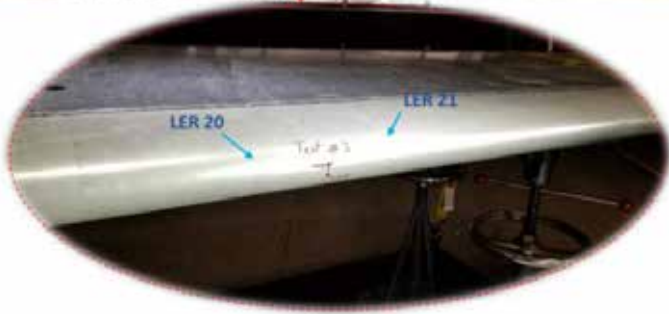
Horizontal stabilizer setup (HS-T3)

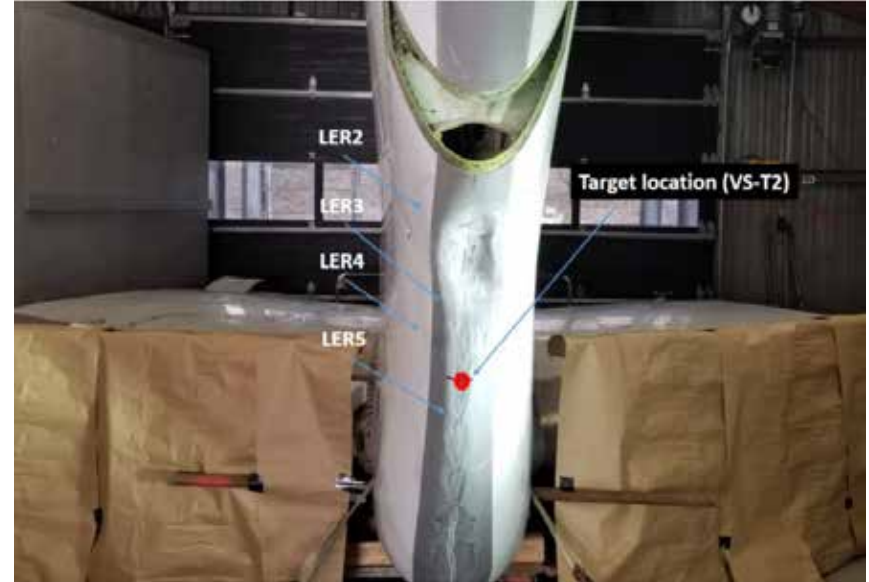
Vertical stabilizer setup (VS-T2)

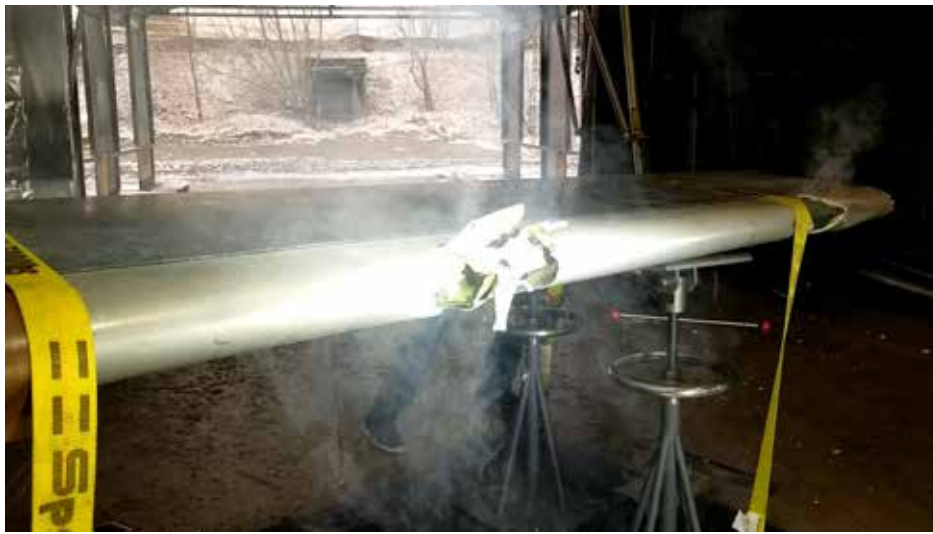
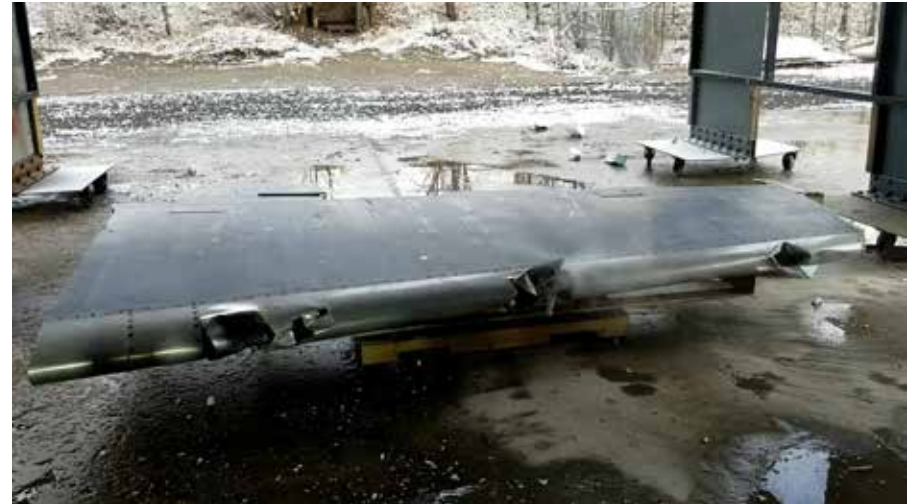
## Drone impact on HS (charged battery)

← **Post-test video**

**~ 4 minutes after the impact** →

- The impact test using charged batteries (LiPo) resulted in severe failure of the batteries cells (generation of toxic fumes, ignition, open flame and elevated temperature).

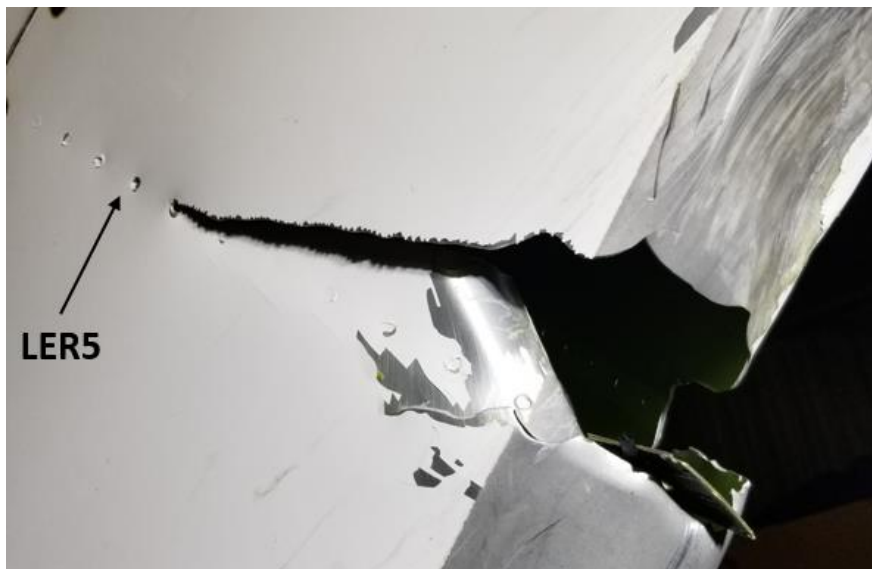
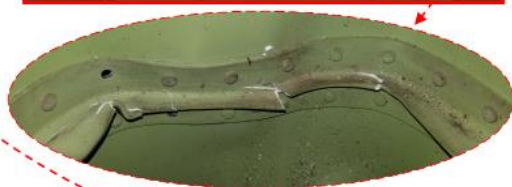
## Drone impact on VS (discharged battery)

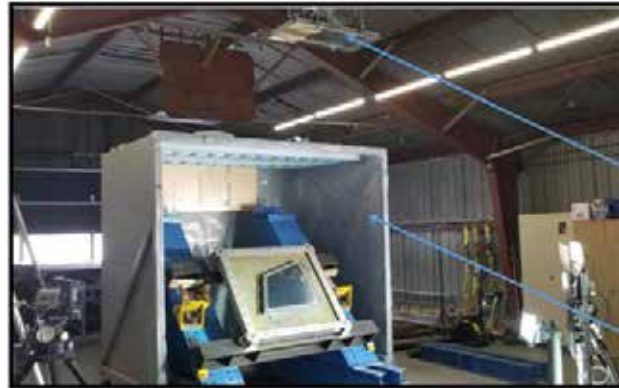
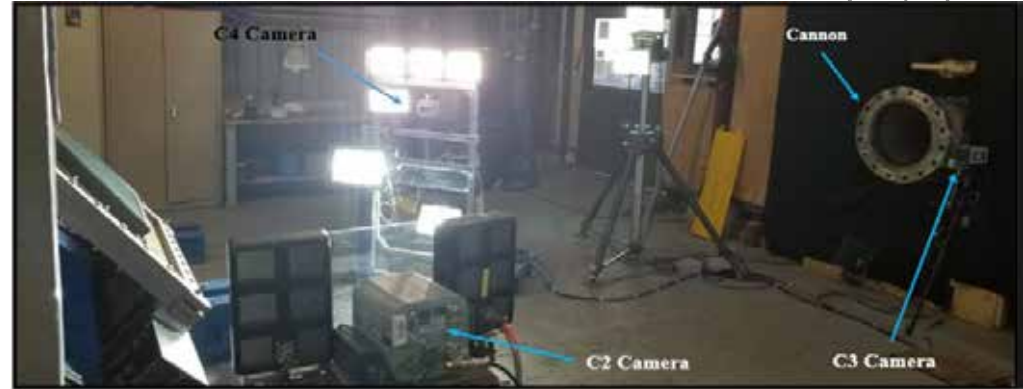
C1 Camera

Mobile debris shield

C4 Camera

Cannon

C2 Camera

C3 Camera

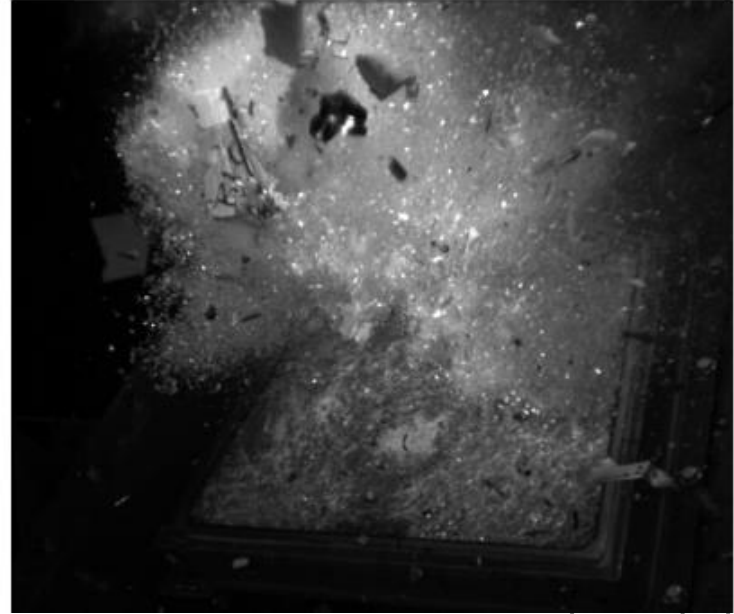
Side view (C2)

Isometric view (C4)

**Generation of cloud of glass fragments during impact  
(Test #2 @ 250 knots)**

- Drone impact on windshields results in a considerable damage especially at the speed of 250 knots. All the glass plies were fractured and a significant amount of glass fragments were released into the cabin (~25% of the structural inner glass pane).
